Guidance on Cable Inspection

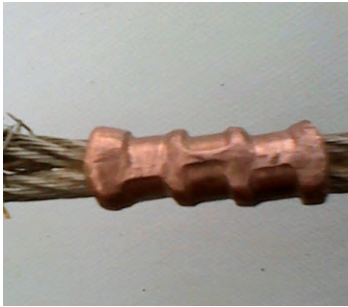
This is a picture of a recently fitted ferrule, note the ends, which are belled or trumpet like, and the crimping tool marks which are well defined and deep.

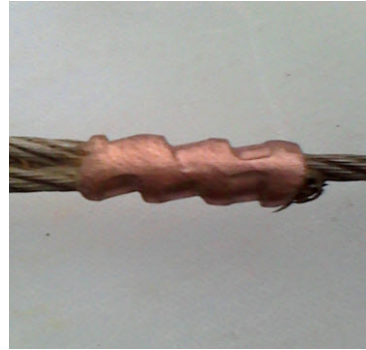
Compare this with the one on the right. Note the ends which have lost the belled look and are

becoming tapered, the crimper marks are less well defined and the material thickness is reduced generally. This ferrule, whilst serviceable for the moment, is well on the way to needing replacement.

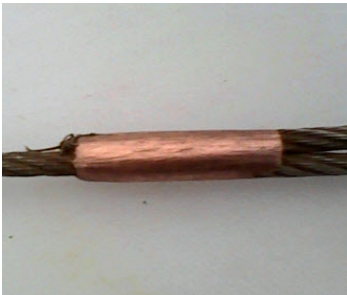
Now compare the one below, well worn, no crimp marks, no bellying whatsoever. This ferrule should have been replaced well before getting to this state. This is a cable break waiting to happen

The ferrule on the right is a similar-looking one that did pull out.

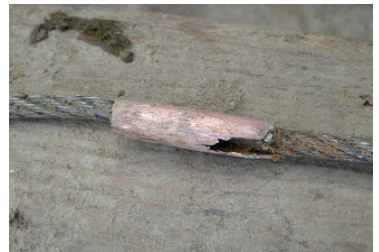
The pictures above show failed repairs. Note the general wear to the ferrule, and particularly at the ends, which are sharp and show none of the flare associated with a newly compressed ferrule. They should have been replaced long before reaching this state.
